Ohio Environmental Protection Agency

Division of Solid and Infectious Waste Management

Kirby Tire Fire & Cleanup

Wyandot County, Sycamore, Ohio

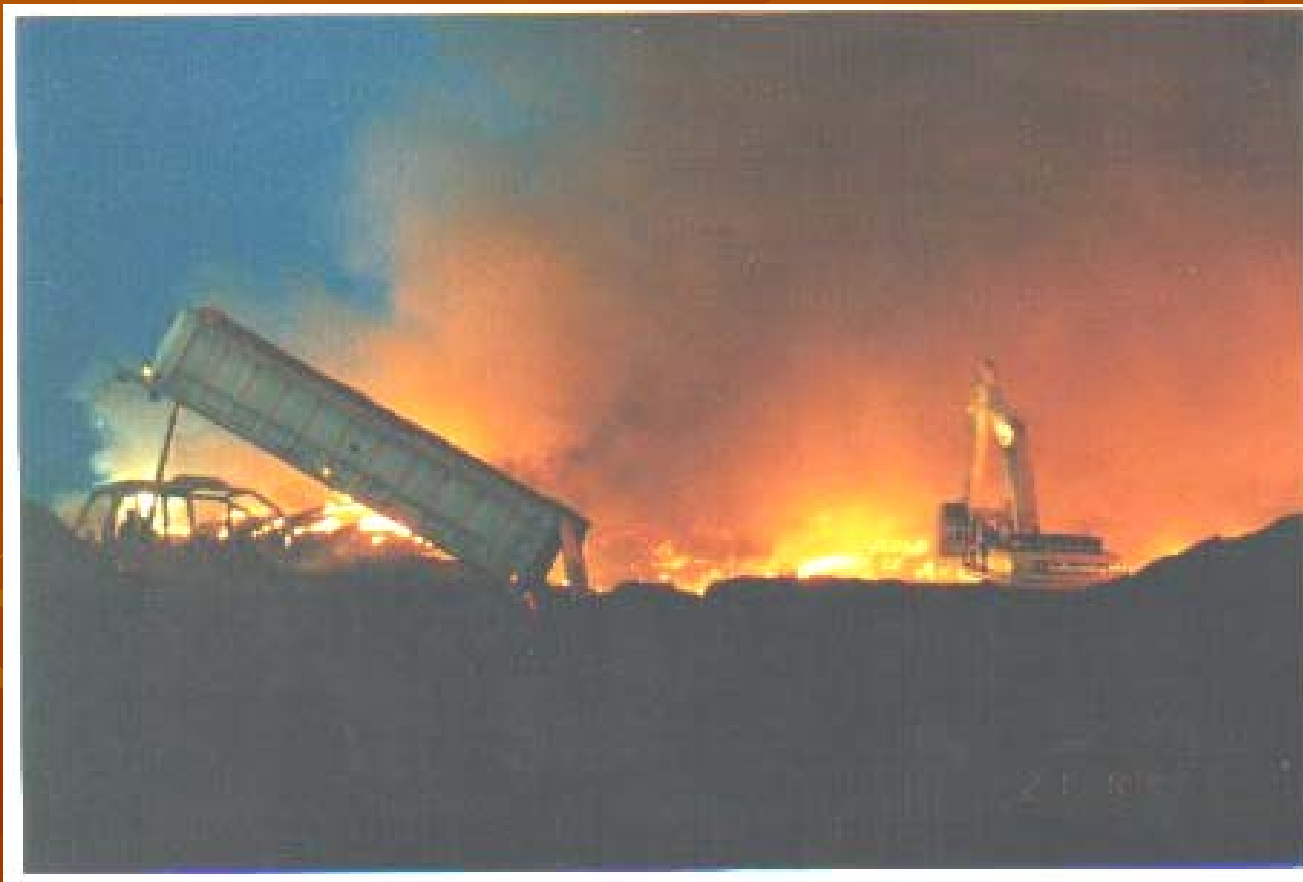
Arrow points
to Kirby site

Also shows
wind direction
on day of fire

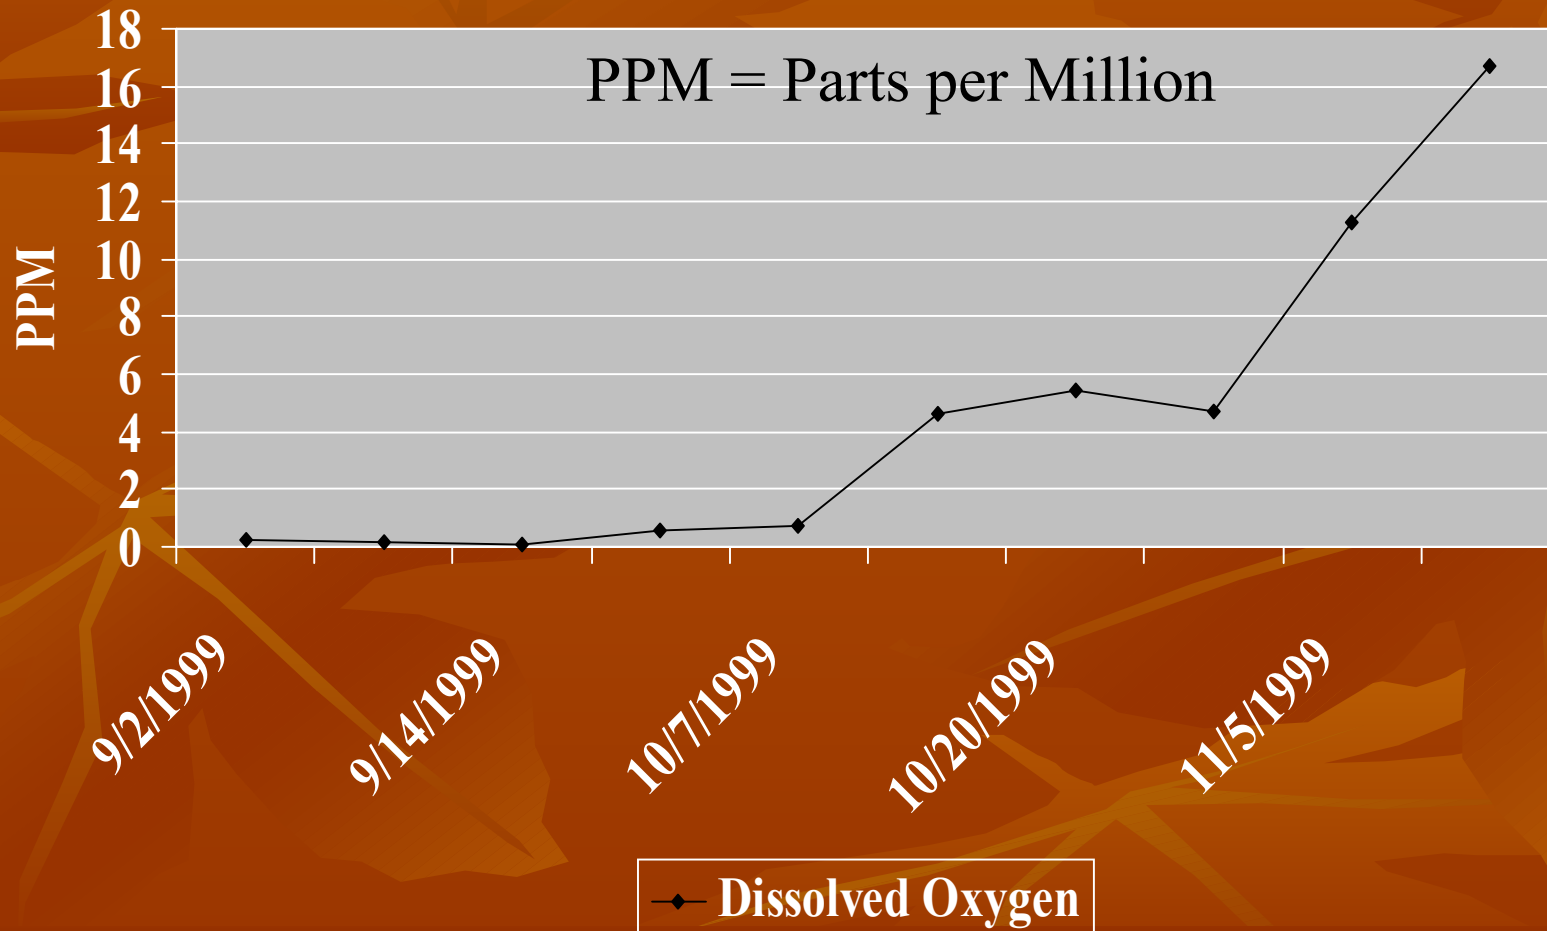
Dissolved Oxygen Monitoring

- Discharges to Sycamore Creek
 - Aug 22 and 23
 - Via field drainage tiles
 - Trench dug looking for addition field tiles
 - Backfilled with compacted clay to create barrier
 - Fish kill for 7 1/2 miles downstream
 - Siphon dams and aeration systems installed

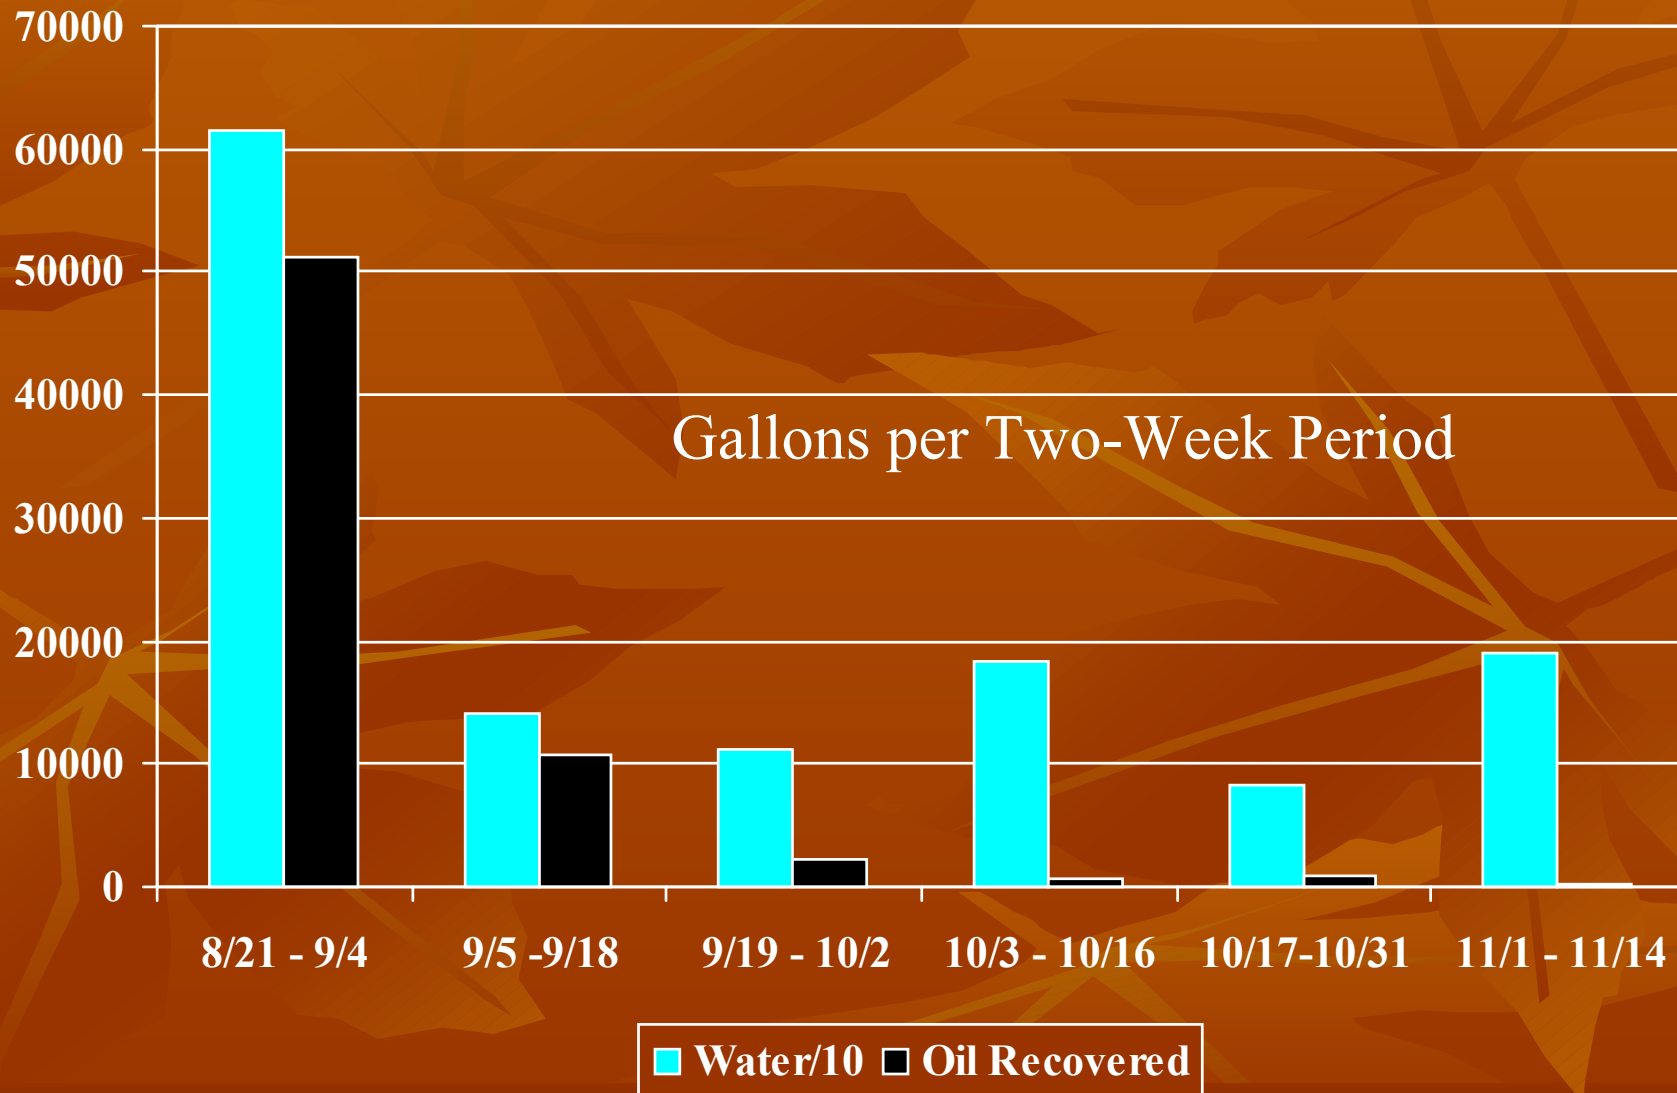
Gallons/10 of Water Processed Gallons of Oil Recovered

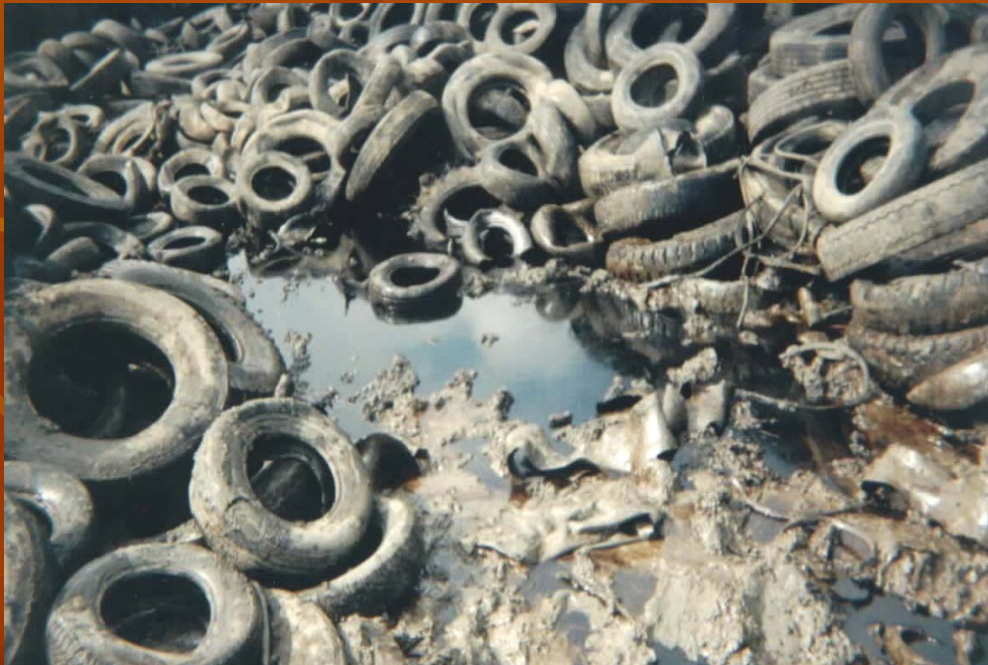
- Pyrolytic action continued for six months
 - Settlement of soil and clay cover, smoke venting
- Trapped pyrolytic oil
 - Oil running out of base of piles after heavy rains

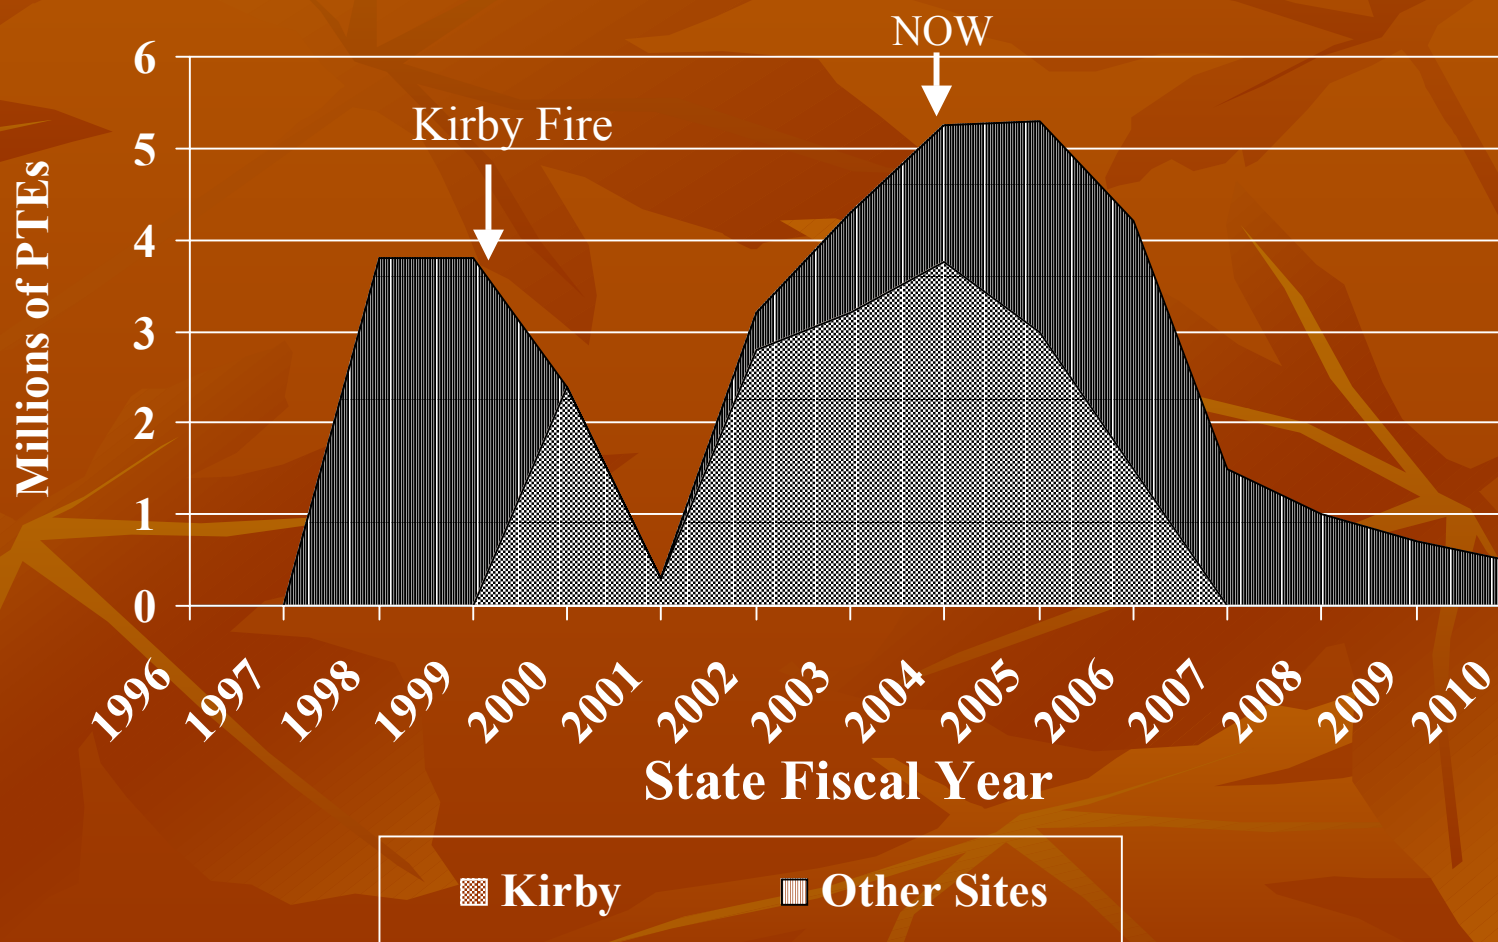
OhioEPA Kirby Scrap Tire Site

September 1999

Wyandot County, Sycamore, Ohio
